Case Study for Underground Basement Wall Leakage and Measures

Manikandan Srinivasan

Transmission Engineering Department, Dubai Electricity and water Authority, Dubai, United Arab Emirates

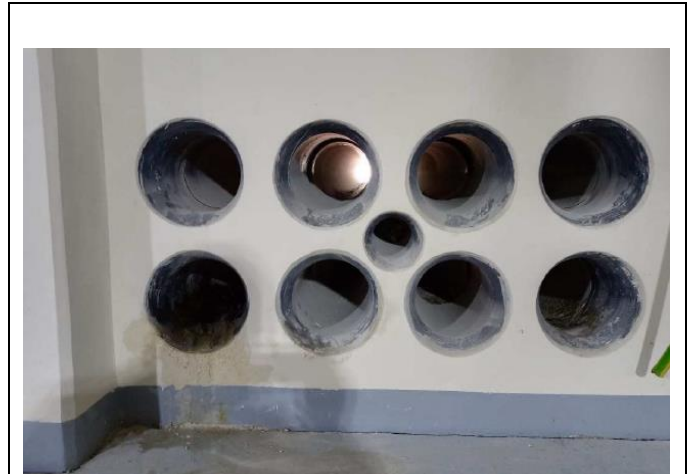
Special agencies investigated the basement wall inside /outside area and damp spot and paint delamination at the affected spot characterize the leak. Hair crack identified in top of basement Ground slabs and in some particular locations, flowing water incidents and AC water accumulation observed.

Dampness at inside basement wall

In order to stop identified water seepages, Soft Elastic sealing – Injection Resin methodology used at the external side of raft/wall joints and around the pipe

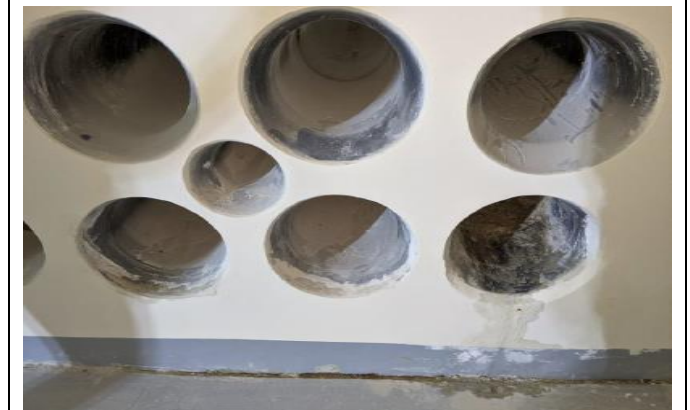
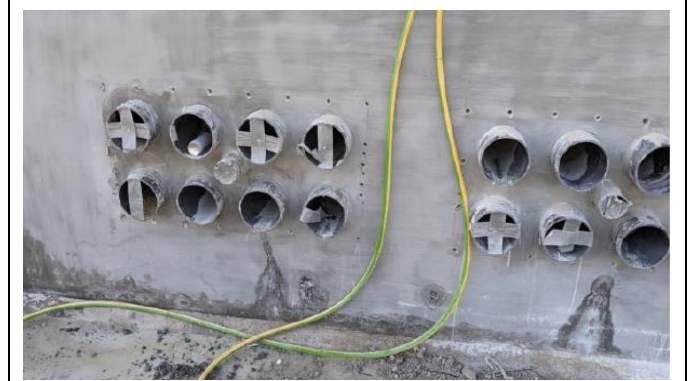
Dampness at outside basement wall

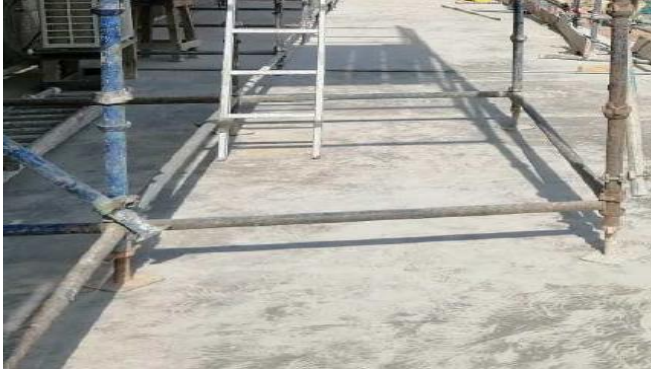
Loading platform slab

- Water is being accumulated inside the soil from the AC service units / Curing water;
- Excess water may poured during soil filling and compaction for ground slab works
- Encased pipe was damage during filling or concreting; the water may enter into the pipes and leads to water leakage through the pipes.
- The leakage from the kicker joints may be due to the breaches in the waterproofing applied inside the pit.
- Breaching of ground slab water proofing through hair crack, which allows water from the loading platform slabs.

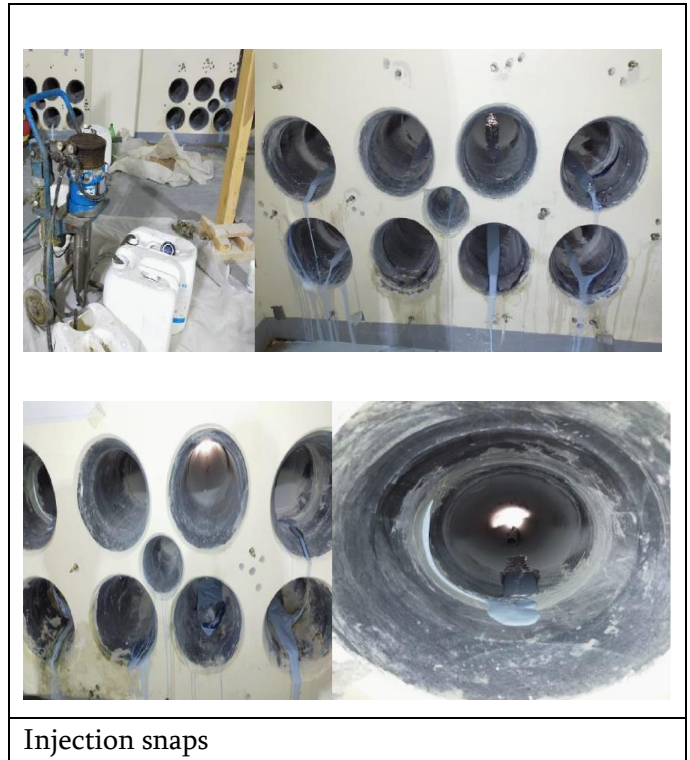
Injection snaps

- The injection will start around the perimeter of the pipe to seal the perimeter from flowing material while injecting in the centre of the sleeves.
- Once the perimeter injection is completed, the contact injection will start in the remaining packers in a sequential method.
- Finally, entire packer injection shall be completed and cure for 24hrs.
- Next day all the packers can be removed, and the packer hole area fill by approved epoxy grout.

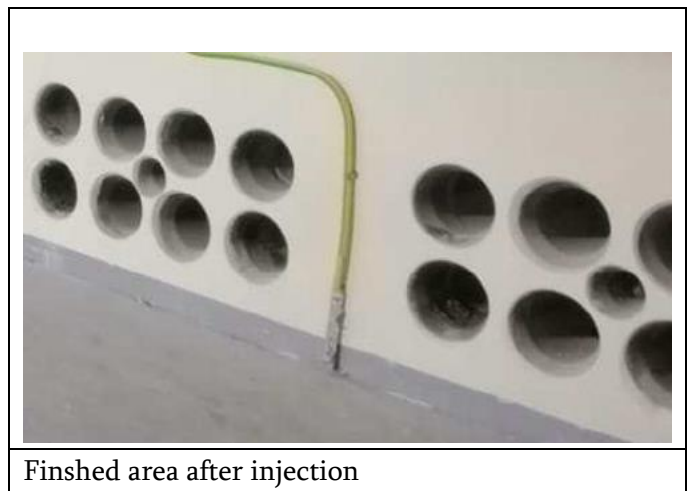
Finished area after injection

MC INJEKT GL 95 injected in all identified locations as per above methodology. The area is completely monitored even after completed the injection and grouting. No seepage observed and successfully all the seepage arrested.

Once the seepage arrested, external basement wall 4mm thick SBS water proofing membrane and internal wall paint works completed.
