Construction Anomalies and need for Waterproofing in UAE

ABSTRACT

Keywords: Foundations, Substructures, Waterproofing, Membrane, Anomalies

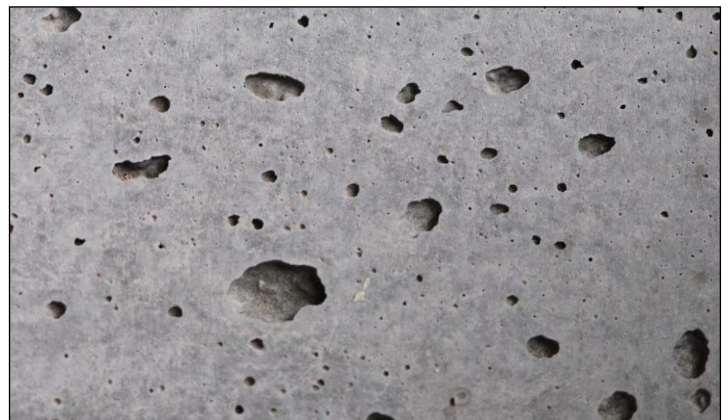
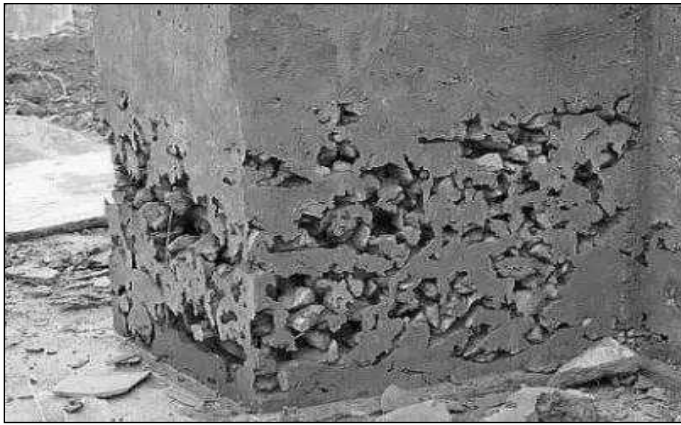
Figure 1. Anomalies during execution: voids and segregation of concrete

Concrete has flaws such as holes, porous areas, and concrete segregation (Figure 1). If there is no coating system in this situation, the degradation agents will have nothing to stop them from penetrating the element, which could lead to a lot of issues. This issue can be avoided if a waterproofing solution is considered from the very beginning of the project, extending not only the service life of the structural element but also that of the membrane and the waterproofing solutions utilized.

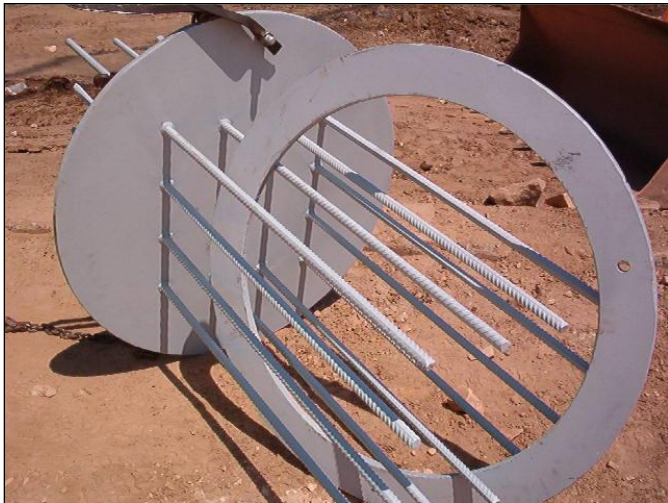
Figure 8. Scheme of Waterproofing system developed by Sotecnisol Company

This solution requires reinforcing the plate with pile head screws and using a new rectangular geomembrane. A new membrane should be connected to the first membrane by welding. In the next step the plate and steel rod are bolted to the pile head. Holes are drilled in the pile heads to accommodate steel rods that ensure a connection to the concrete. A ring-shaped membrane is then applied with holes only where the heat-welded screws are located so that the membrane can be attached between the plates. Finally attach the plate. Figure 8 shows this system before it was placed on the foundation.

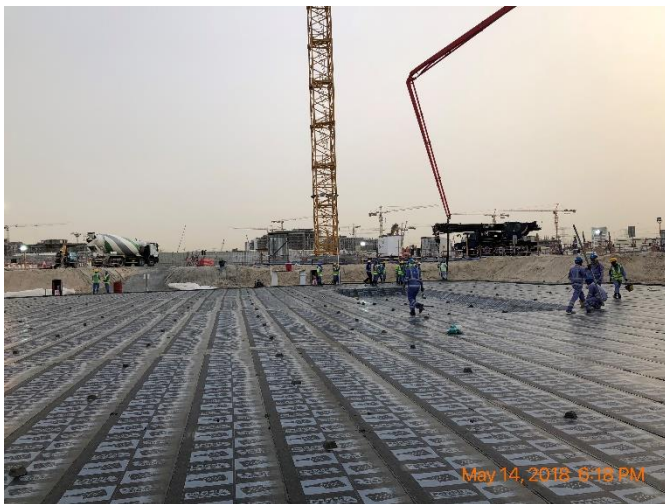
Figure 11. Waterproofing system bottom of Mat Slab connected with vertical

foundation, part of the membrane is left uncovered and connected to the masonry. This solution should be finished with a cement-based coating. Membrane finish details should be finished with grooves or grooving where mastic is applied in vertical applications to ensure a connection between the base and the membrane. The connection between the mastic and the tarpaulin prevents water penetration between the sheet and the wall. Figure 11 shows a schematic of this coating method placed on the bottom surface of a concrete slab.
