Case Study for Underground Basement Wall Leakage and Measures

Manikandan Srinivasan

Transmission Engineering Department, Dubai Electricity and water Authority, Dubai, United Arab Emirates

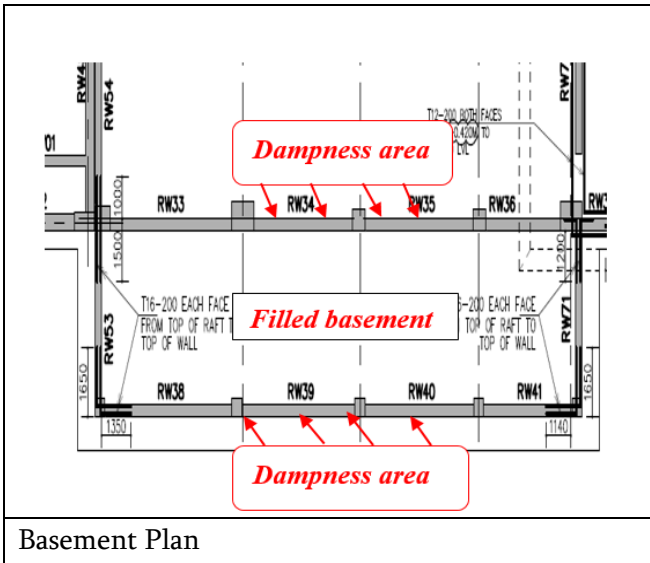
Basement Plan

Water leakage observed in the following locations

- Around the duct bank
- Through the sleeves
- Along the kicker joints
- Along slab-wall joints
